## FIRE RESISTANCE TEST REPORT

### DOUBLE LEAF COMPOSITE TIMBER DOOR with GLAZED ELEMENTS AND SIDE & OVERHEAD PANELS

in accordance with **BS EN 1634-1: 2008**

**Report Number: IT 13-247**

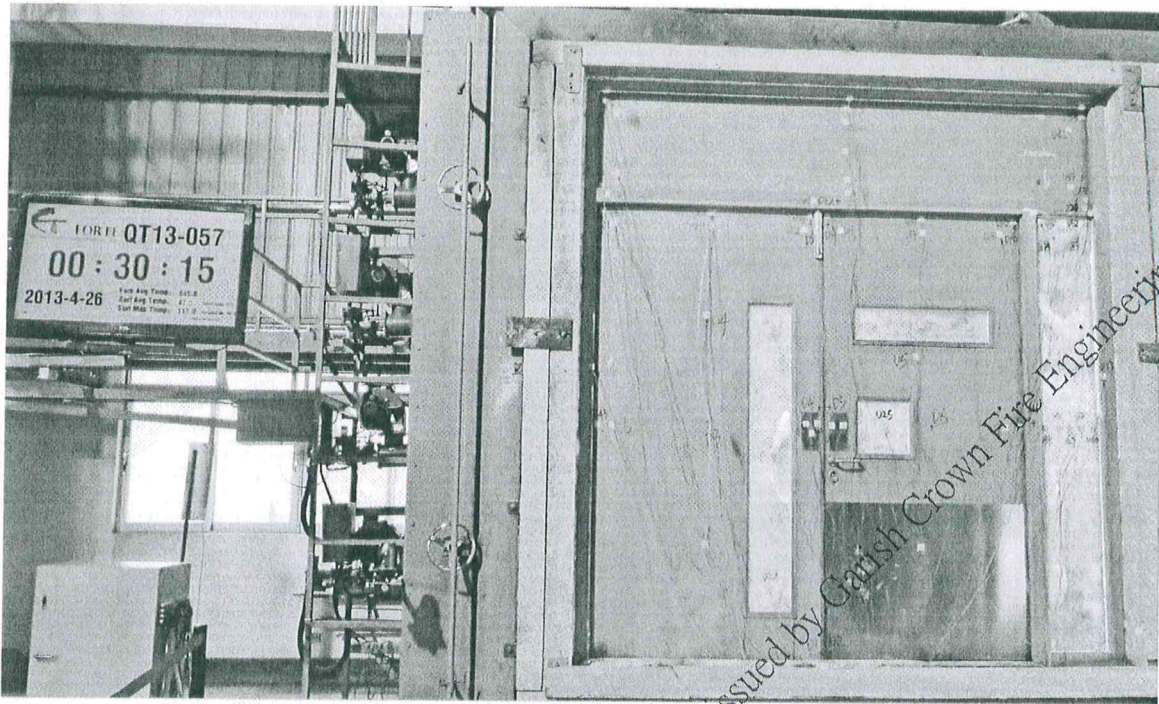
**Photo 3.** Unexposed surface of the specimen at 30 minutes of test.

29.23	Unexposed surface of glass panels on inactive leaf cracked.
30.00	<b>No integrity failure had occurred.</b>
31.06	Smoke released from the top glazing beads of upper glass panel on inactive leaf.

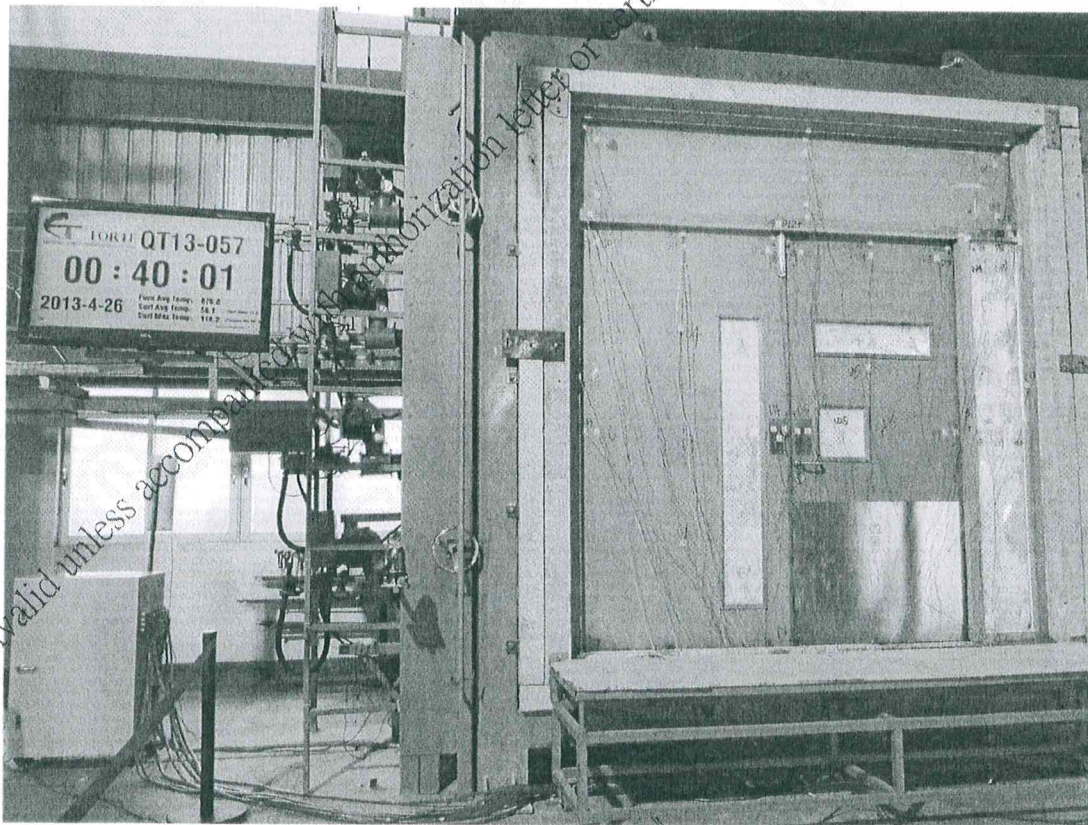
**Photo 4.** Unexposed surface of the specimen at 40 minutes of test.

31.46	More cracks observed from the side glass panel.
34.16	Intermittent flaming was observed from the bottom of meeting edge.
37.33	Smoke released from meeting edge and cracks on glass panels.
