TEST REPORT

TEST REPORT NO.: R07L06B

Fire resistance test conducted in accordance with BS 476: Part 22: 1987, Section 7 on a partially insulated, double-leaf timber doorset**1. Summary**

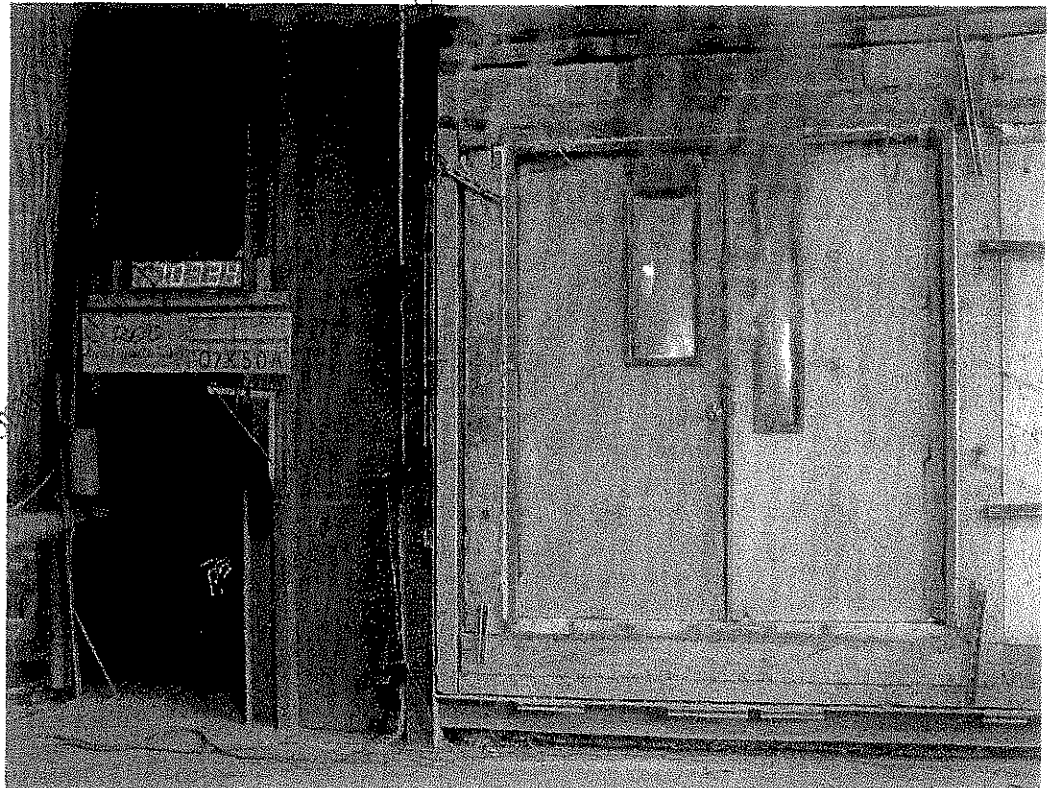
Photo 4: The unexposed face of the specimen after the test.

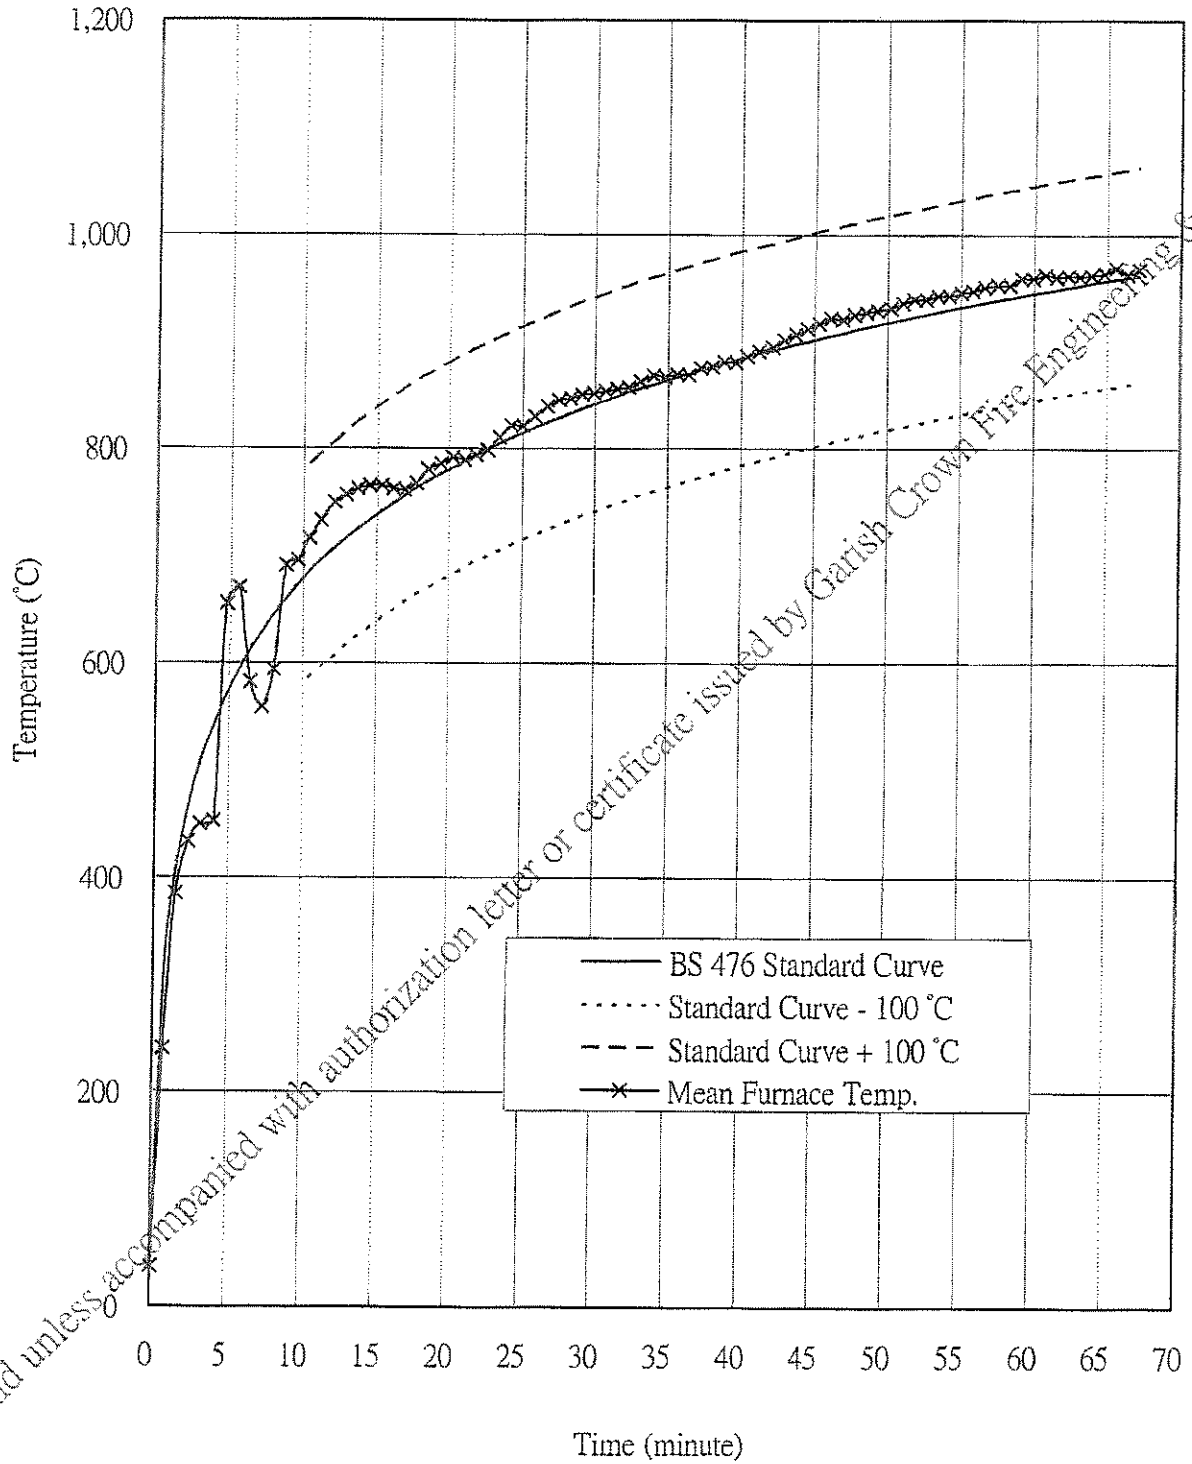
Figure 5 – Mean furnace temperatures.

The furnace was controlled so that the mean furnace temperature complied with the requirements of Clause 3.1 of BS 476: Part 20: 1987. The temperatures recorded are shown graphically in Figure 5.
